# Manhole Inspection Summary

Manhole # S13S\_\_005MH

**Location** Address: **2907 Benson Ave**

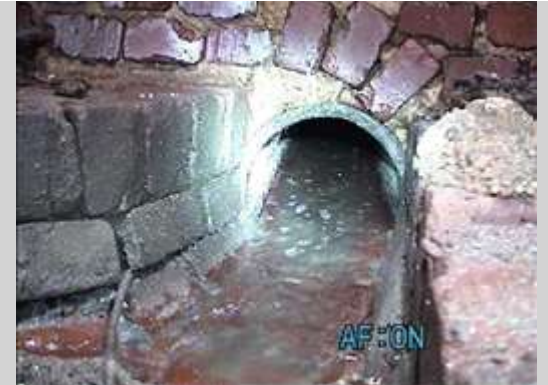
12 O'Clock Outflow

8 in. Circular Gravity Sewer  
Pipe Out @ 12 O'Clock

Pipe Height: **8.4** (in.) Rod and Bar (Angled)  
Pipe Material: **Clay** ☐ Pipe Lined  
Invert Depth: **7.02** (ft.) Flow Characteristics: **Slow**  
Deposits: ☒ None ☐ Mud ☐ Sludge ☐ Debris ☐ Grease  
Silt Depth: **0** (in.) Deposits Extent:  
Infiltration: **None** Pipe Seal Cond: **Sound**

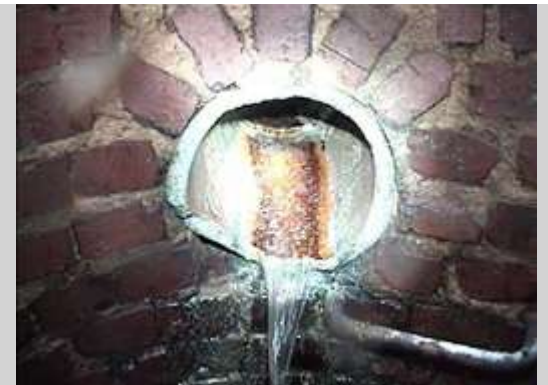
6 O'Clock Inflow

8 in. Circular Gravity Sewer  
Pipe In @ 6 O'Clock

Pipe Height: **8.4** (in.) Rod and Bar (Angled)  
Pipe Material: **Clay** ☐ Pipe Lined  
Invert Depth: **6.96** (ft.) Flow Characteristics: **Slow**  
Deposits: ☒ None ☐ Mud ☐ Sludge ☐ Debris ☐ Grease  
Silt Depth: **0** (in.) Deposits Extent:  
Infiltration: **None** Pipe Seal Cond: **Sound**

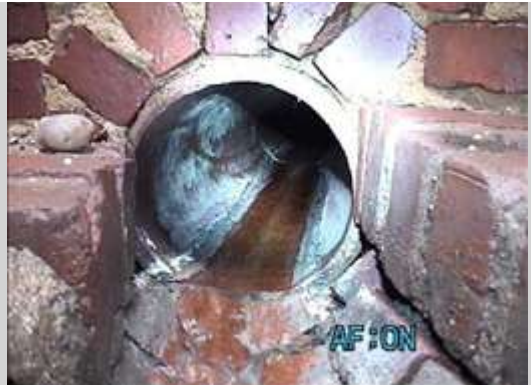
9 O'Clock Inflow

8 in. Circular Gravity Sewer

Pipe In @ 9 O'Clock

Pipe Height: **8.4** (in.) Rod and Bar (Angled)

Pipe Material: **Clay** ☐ Pipe Lined

Infiltration: **None** Pipe Seal Cond: **Sound**
